WORK INSTRUCTION

FOR SLIP BASE POLE FLANGE BOLT RETROFIT

**RETRO-FIT OF BOLTS, NUTS AND WASHERS AT
FLANGE PLATES OF SLIP BASE POLE INSTALLATIONS
(WITHOUT LIFTING POLE)****Scope**

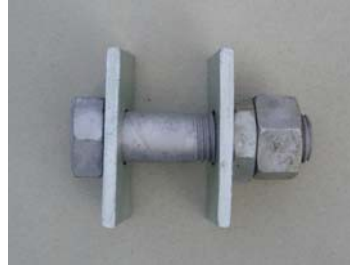
Components for one slip-base pole bolt assembly retro-fit

This procedure requires three M30 Grade 4.6 bolt assemblies. Each assembly shall include:

For new installations, all components for the bolt assembly shall be supplied with the pole.
For retro-fit of existing installations, the existing bolt (if a minimum of 115 mm long) and the main nut may be re-used if there is no damage or wear to these items.

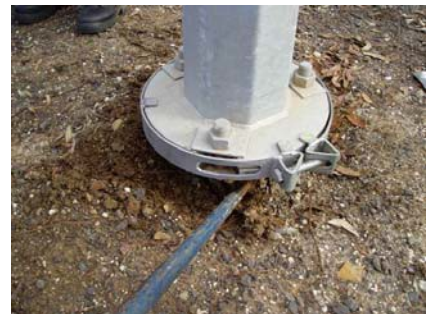
Step 2. Ensure clearance of bolts from soil and vegetation, using excavation tools as appropriate to remove soil; and debris. A minimum clearance of 100 mm below the lower base plate is required to fit the clamps, remove and replace the bolts and to fit the ring spanner to the bolt head.

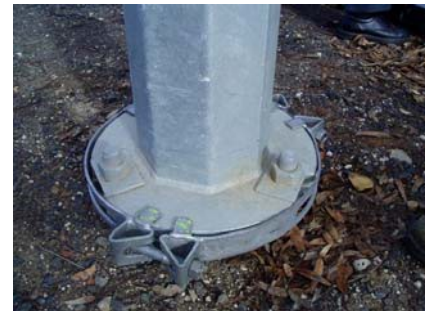
Step 3. Install the flange base band around the pole base and tighten the band nuts to finger tight, ensuring that the bolt threads protrude through the nuts. Ensure that the tabs on the band are resting on top of the pole flange surface and the inspection slots align with the pole bolts.

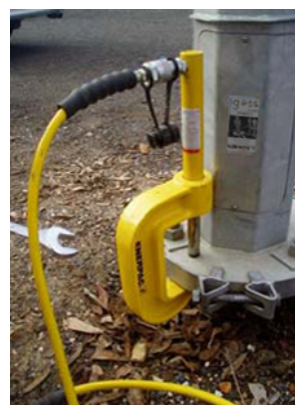
Step 4. Clamp the assembly using three G-clamps of minimum SWL 15kN x 2 = 30kN; or the hydraulic "C" clamp and hand pump to the correct pressure (2 tonne) next to the bolt to be removed. Use steel packers to prevent damage to the galvanized base plates.

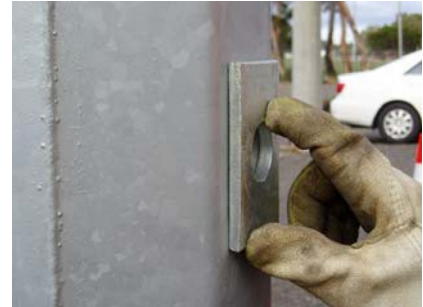
Step 7. Check that all components for the new bolt assembly, as described in the component list above and including any re-used items, are present prior to commencing installation. Ensure that:

- All components are clean, use a wire/stiff brush to ensure parts are free of dirt and debris
- The 10 mm thick rectangular washers are flat to within 0.5 mm over the 100 mm length.

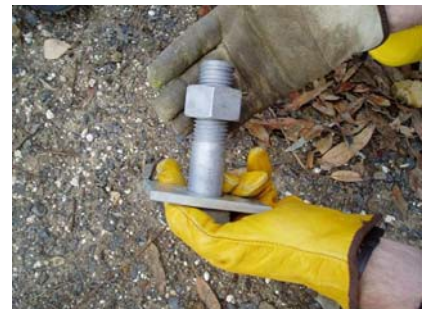
Step 8. Before installing the bolt, run the locknut up and down the length of thread to be used to remove potential excess galvanizing and develop a consistent friction in the threads. The flange bolt assembly must be replaced if the nut cannot run freely along the bolt. Using some heavy duty anti-seize lube or lightly oiling the threads will assist.

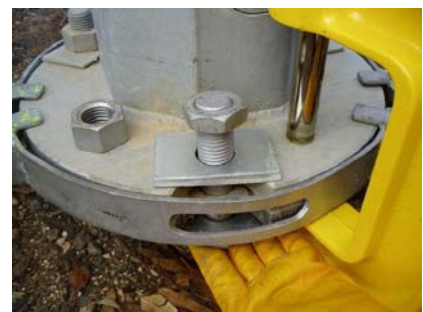
Step 9. Place one flat rectangular 60 x 100 mm Grade 250 steel washer, 10 mm thick at the lower side of the joint and install the M30 Grade bolt, with the head lowermost. It is better to install the bolt closer to the inner most position of the vee of the base plate.

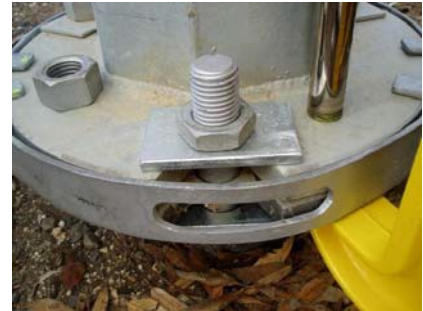
Step 11. Fit the half nut (15 mm high) to hold the assembly in position.

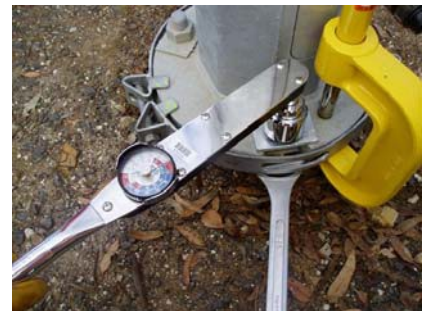
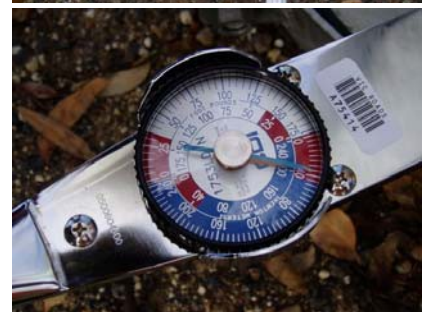
Step 12. Align the rectangular washers so that the long edge of the washers does not protrude past the pole flange edges and is parallel to the Vee opening.

The photo opposite shows an unsuitable position, washer edge not parallel to the Vee opening.

Step 13. Use the torque wrench and the ring spanner to tighten the half nut to a snug-tight condition, so that all joint members are in contact with each other and gaps are closed. Torque shall not exceed 40 Nm.

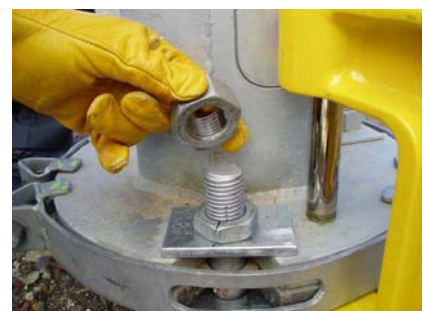
Step 14. Install the main nut (26 mm high) to finger tight position.

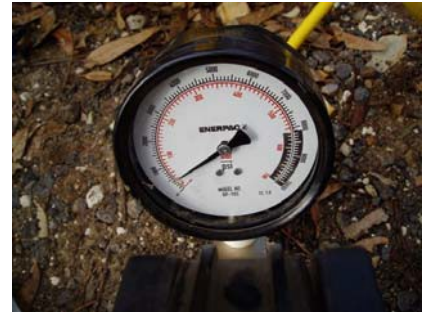
Step 15. Slowly reduce the clamp pressure to one tenth of the initial value, i.e. to 200 kg. This step is required to simulate the clamping force that is slightly less than that applied when the bolt assembly is tightened to 95 Nm.

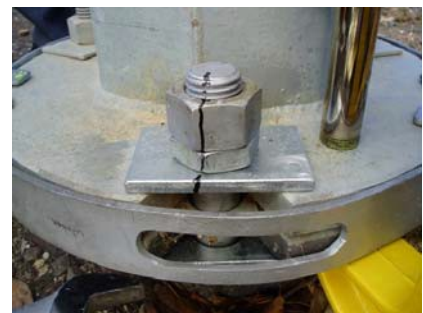
Step 16. Mark the position of both nuts with respect to the bolt and washer, using a marking pen. The mark is to extend in a continuous line from the end of the bolt, down the sides of the two nuts and onto the washer. The mark is to show that the main nut has rotated relative to the bolt and that the half nut has remained fixed relative to the bolt.

Step 22. Re-check tightening torque of each bolt assembly, and adjust upwards only if required.

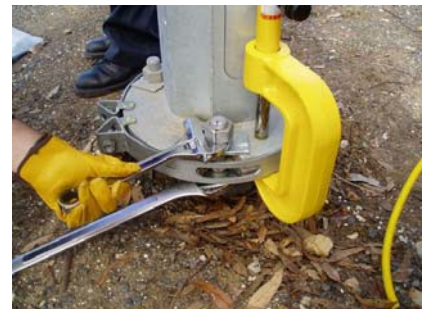
Step 17. Fit the open-ended spanner to the half nut.

Step 18. Fit the ring spanner to the M30 Grade 4.6 bolt head

Step 19. Hold both spanners firm while tightening the main nut.

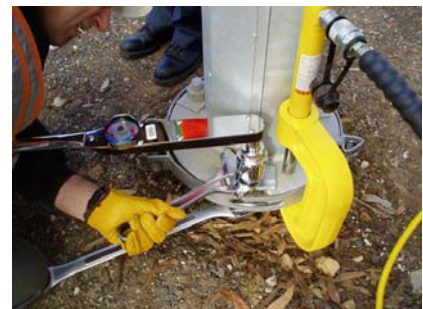
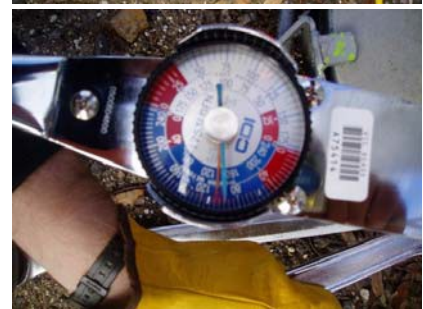
Step 20. Tighten the main nut as follows (by the second operator):

- Ensure that the torque wrench is set to the correct torque (95 Nm).
- Fit the socket of the torque wrench to the main nut.
- Apply the appropriate torque, 95 Nm, to tighten the main nut.

Cease applying the torque when the trip indicator operates.

Do not exceed the required torque value of 95 Nm.

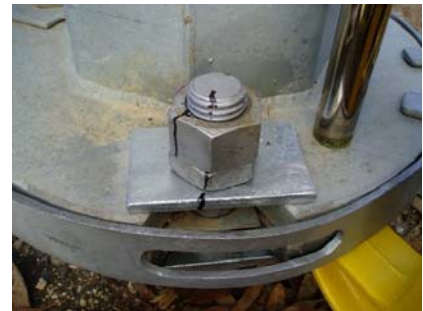
Step 23. Observe that the mark on each bolt lines up with the mark on the half nut and that only the mark on the main nut is displaced. Record observations. If the half nut is displaced relative to the bolt, as evidenced by the marks, the clamping force on the plates is not correct. If the main nut is not displaced relative to the bolt, the clamping force has not been applied. In both cases, recommence the procedure at Step 7.
